## ENVIRONMENTAL ASSESSMENT OF WATER EROSION IN BOVILLA CATCHMENT BASIN AND ITS IMPACTS ON WATER POLLUTION

Watershed basin of water Bovilla was created by surface watercourses and catchment basin groundwater of the Bovilla area. Water collected in the water basin constitutes the main reserve source of drinking water for the city of Tirana. A portion of it is planned as well to be used for irrigation of plants cultivated in this area. Catchment basin is part of the administrative geographical unit of the Tirana district. Topographic relief is relatively steep slope over 15%. The soils of the basin are used and continue to be used for the growth and expansion of forests, pastures, little agricultural plants and partly cultivated land without vegetation. Water erosion of soil in this basin is very visible and reaches very high values. The effects of erosion are visible not only in the loss of land but also in water pollution of the watershed basin. Factors that cause erosion are geological construction of the soil, climate, landscape rake, lack of vegetation cover and land composition. Solids and organic matter transported through surface and ground water are the main causes of reduc

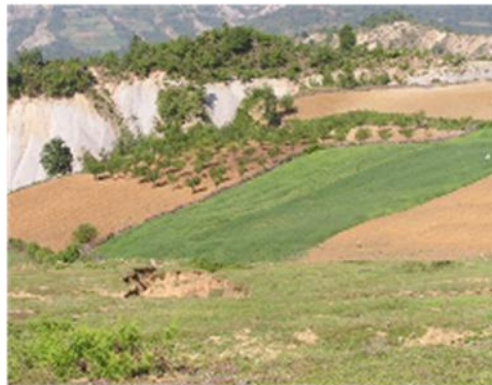
Fig No. 5 Images of good management and bad land in water basins(Kerrabe, Tirane)

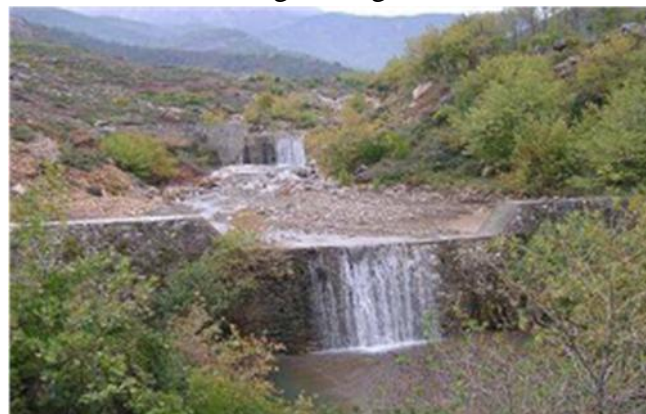
Fig No. 8 Embankment built with concrete

Infrastructure preventive measures, depending on the effectiveness of the construction and construction techniques are: embankment expected to be prevent the movement and transport of soil, builded with simple wooden tools (fences). Fig Nr 6 and 7 of simple embankment builded with stone material with or without mortar.

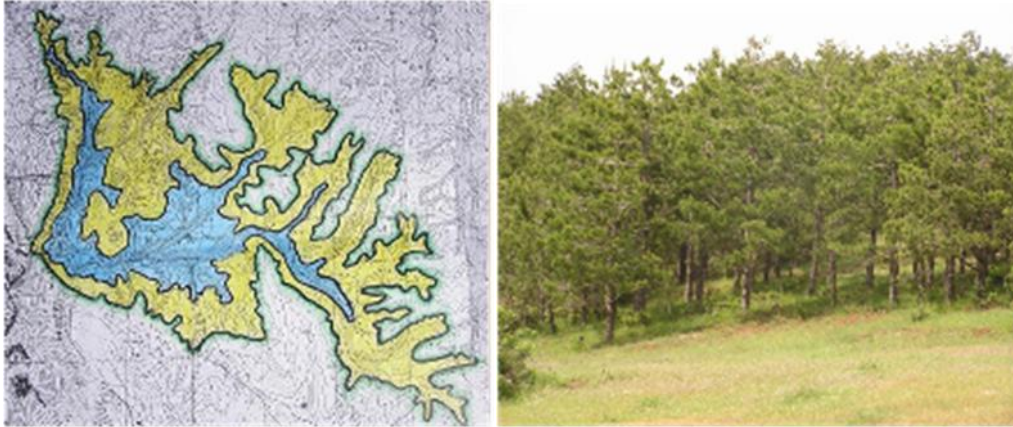
Preventive measures of biological character, consist mainly of implantation of forest trees, shrubs and pastures. Fig 9 and 10 for building overlooking the generation of various protective vegetation.

Fig. No.9 & 10 Protection of water basins
